# YU220 advanced edition maintain service V1.0

Huawei Technologies Co Ltd

# CHAPTER 1 MAINBOARD OPERATING PRINCIPLE

## MOBILE PHONE FUNCTIONAL BLOCK DIAGRAM INTRODUCTION

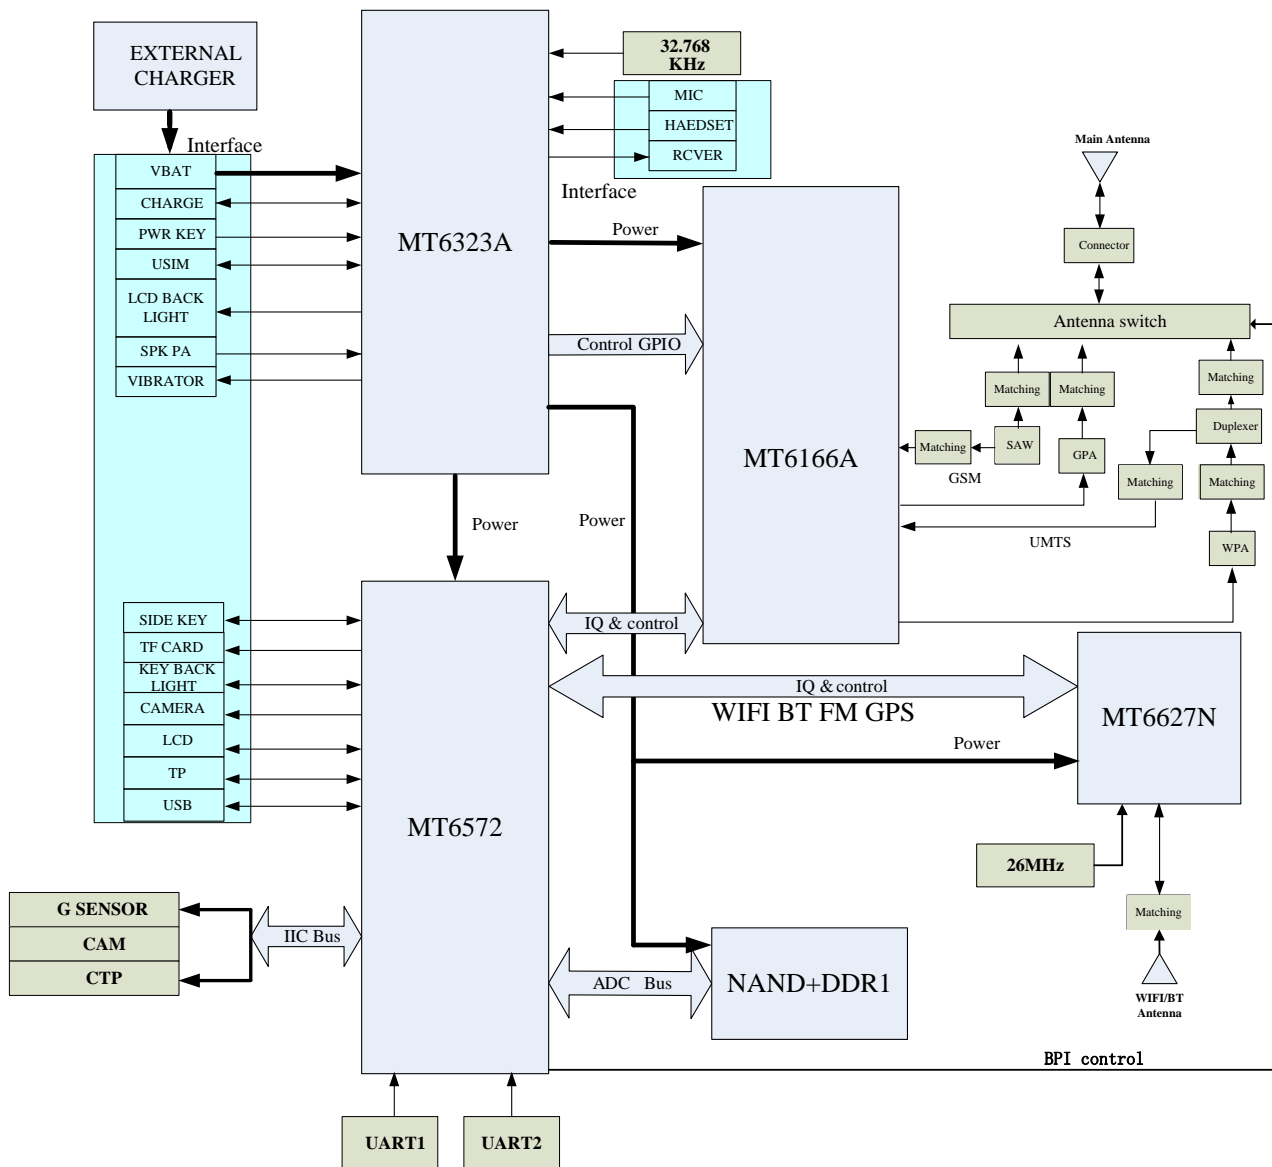
MT6572 is baseband signal processing chip, which in charge of IMAGE, VIDEO, AUDIO, RF INTERFACES, CONECTIVITY signal input and output dispose. Baseband Interface section provides SIDEKEY、 LCD、 SD card、 Bluetooth、 CAMERA、 TP connector and so on.

MT6323 provide frequency including PA,VBAT input switch, output DC-DC,LDO ,

SIM card , LCD backlight and so on ;

MT6166 is radio-frequency signal transceiver chip. Complete up and down RF signal transformation.

According to logical function, veneer can be divided into base band、RF、 power and user interface including four subsystem. Each subsystem including module and cell and realized function as show in picture.

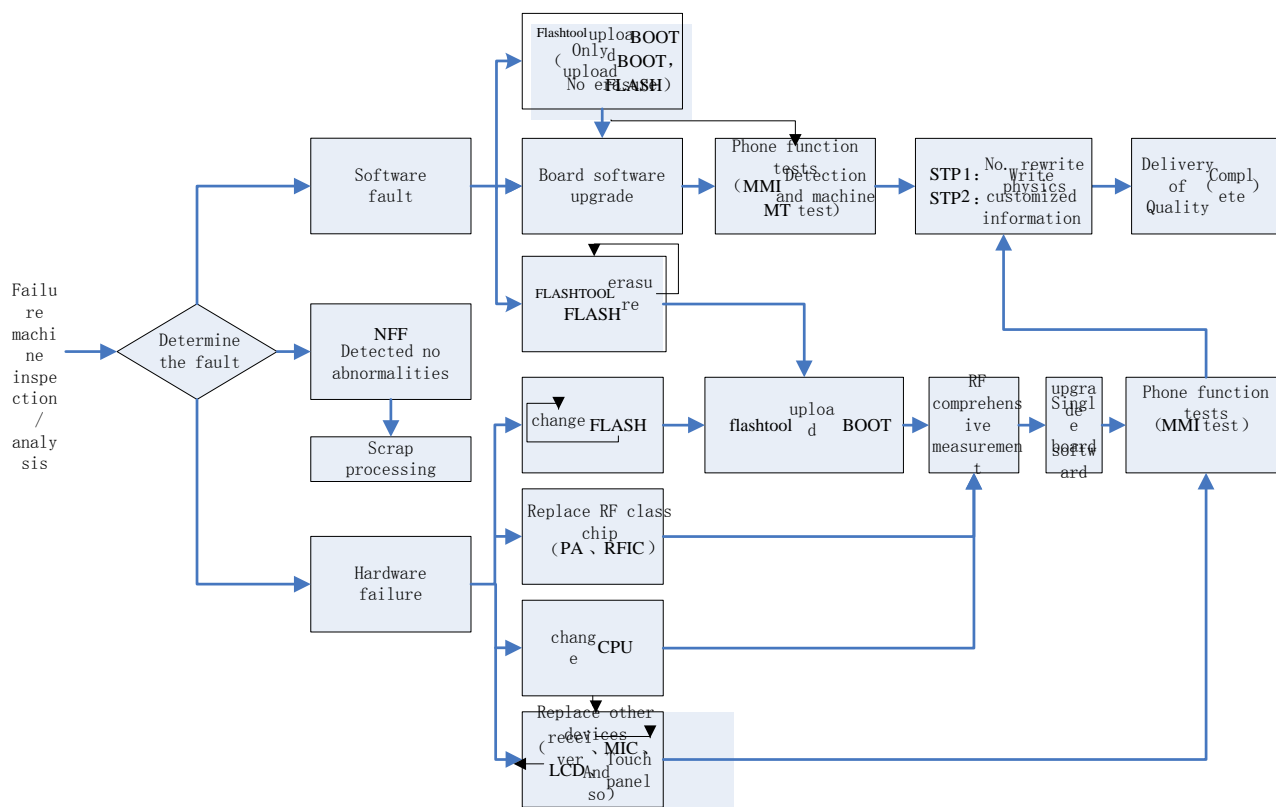
## Host machine maintain flow

### Step explain :

FLASHTOOL half-erasure FLASH : FLASHTOOL half-erasure FLASH no erasure FLASH , information of intrinsic RF correct will not lost, it doesn' t need to correct. Specific loading method can refer to below FLASHTOOL loading guidance.

FLASHTOOL erasure FLASH : After erasure FLASH, all information in FLASH will be erasure and empty.

MMI test : MMI test is phone system comes with function self-test software, pass MMI test can simple and fast judge mobile phone function whether good. The specific test method can refer to primary service manual.

Complete machine MT test : Complete machine MT test is Part of the whole antenna signal test, pass MT test can judge mobile signal whether good. Specific operational approach can refer to RF test guidance.

Rewrite physics NO. : Rewrite IMEI、SN、BT、MAC address information. This

RF calibration measurement: RF calibration and RF functional test, pass RF calibration can make mobile RF performance to reach the best state; RF functional test can detect whether the indicators of RF compliance. Specific test methods can refer to measurement guidance and supply by other document.

Mainrboard repair process description: mainboard repair process, please refer to the host repair processes, the difference is that recognize it not need to make the host MT test after fault repairing.

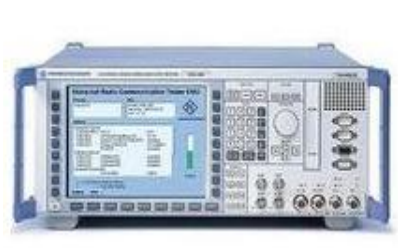
<p>Name : CMU200</p> <p>Purpose : RF calibration</p>

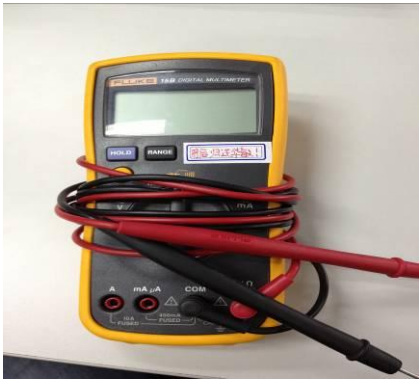
<p>Name : Multimeter</p> <p>Purpose: measuring voltage and current</p>

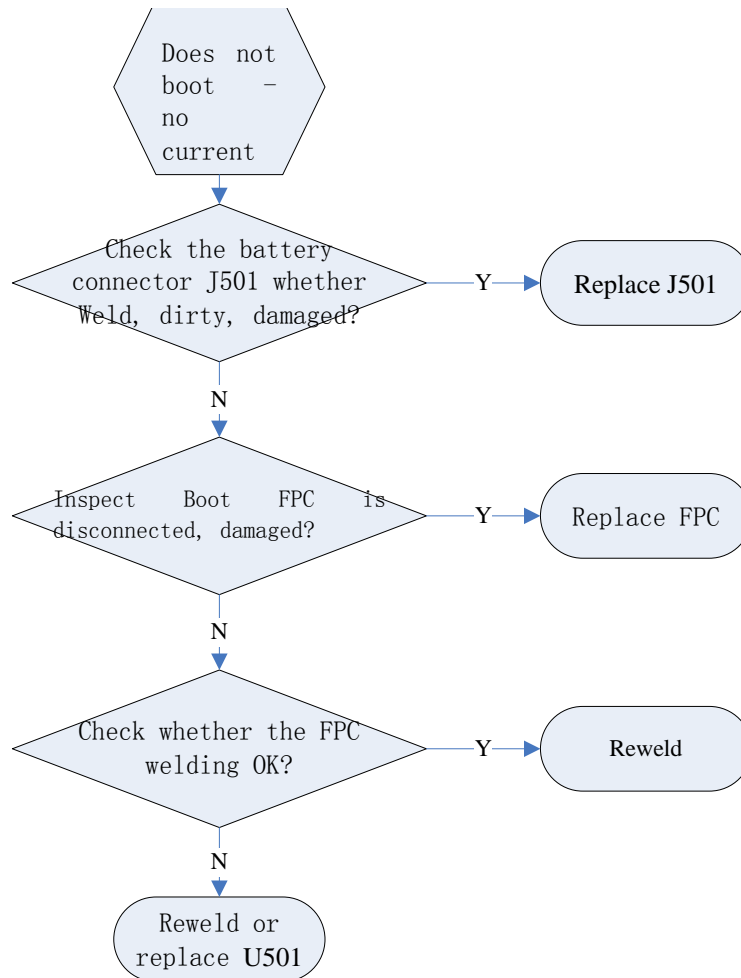
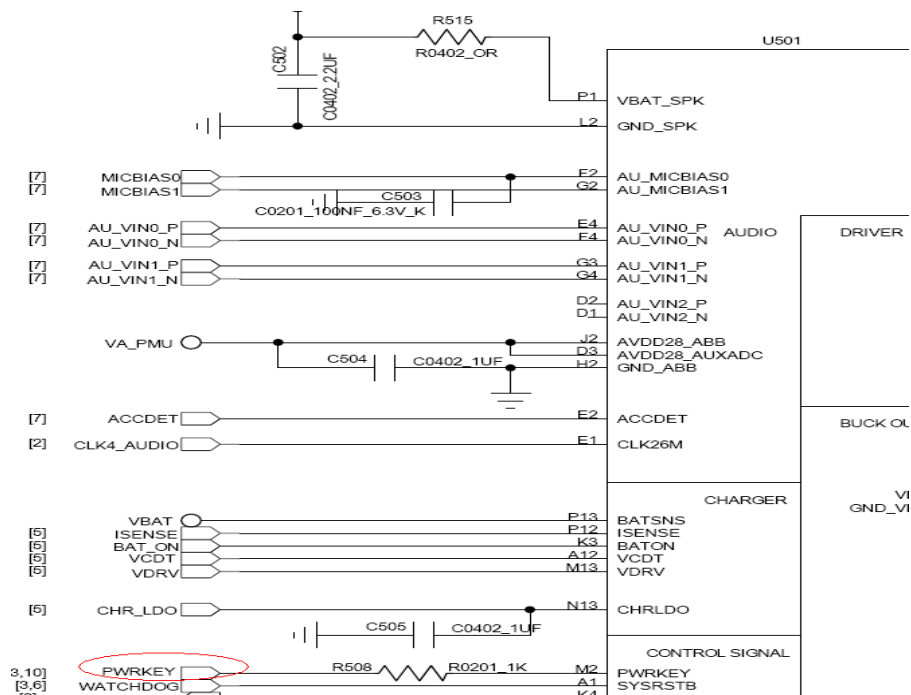
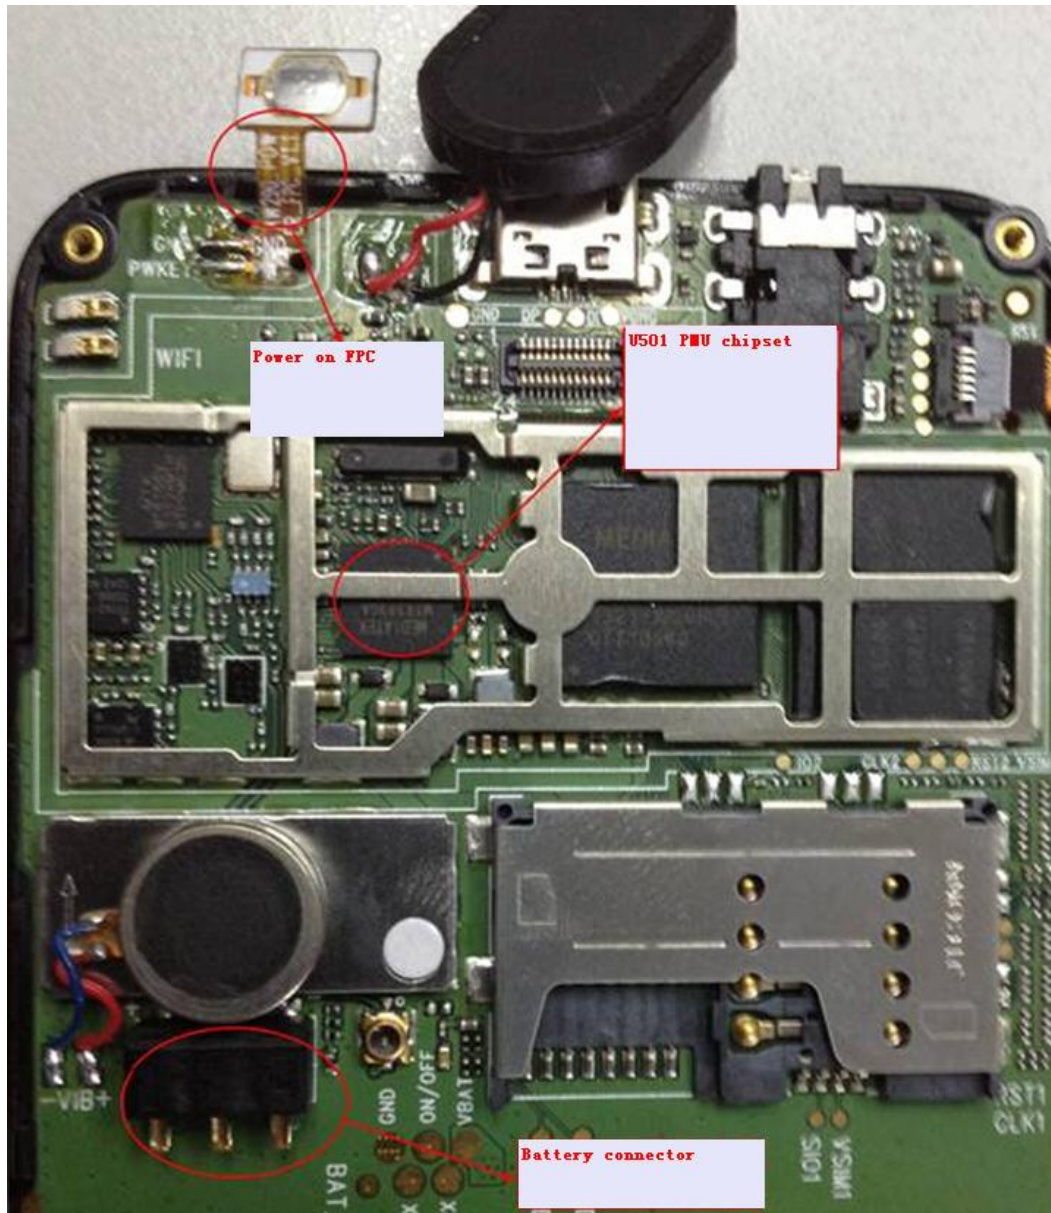
#### 1. 4. 1 No current (direct-current main power supply)

No current ordinary have three probable reasons : 1. Battery connector dry joint ; 2. Power key damage ; 3. Power key relevance circuit or power manage chip damage.

Maintain flow :

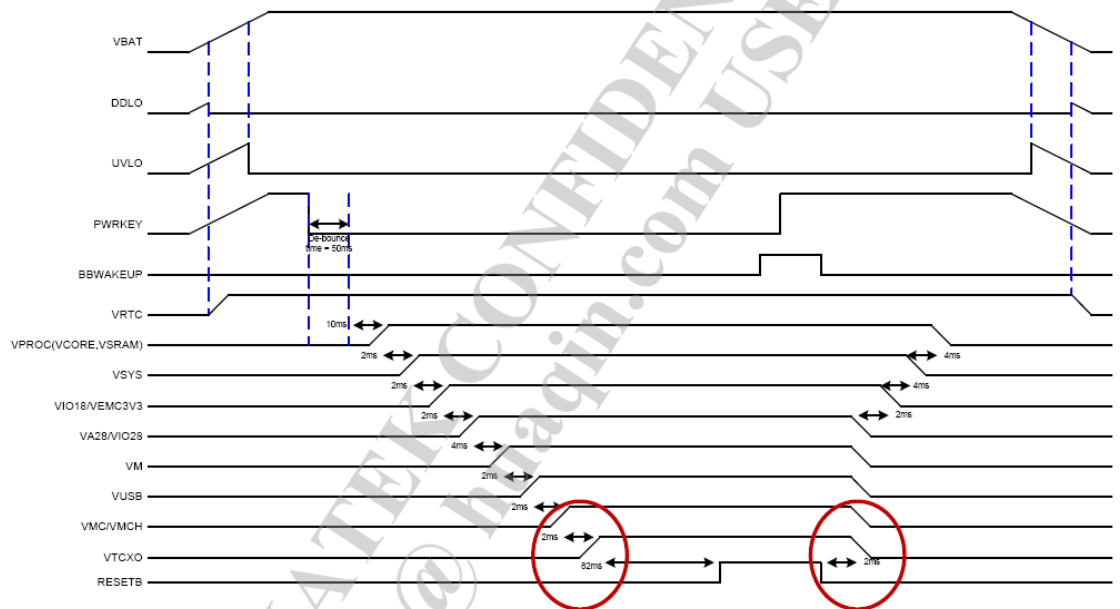
Boot sequence diagram on electricity

## Power on/off Sequence / 32K (by PWRKEY)

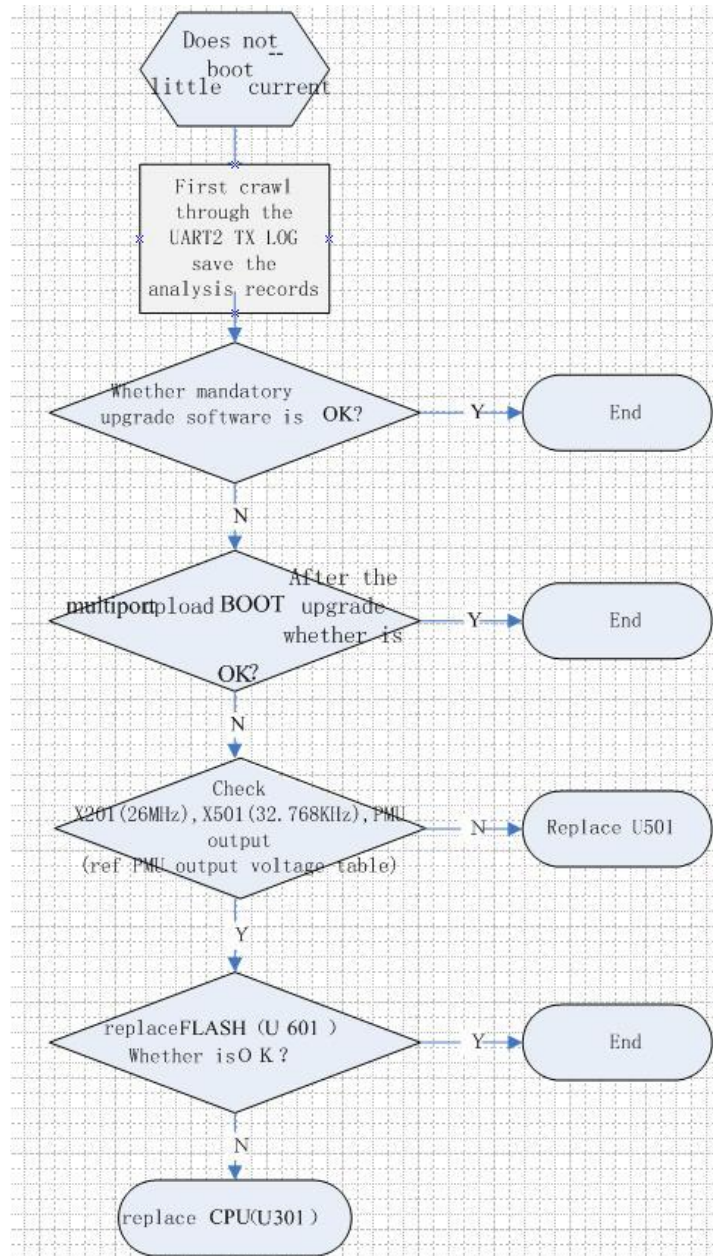
Maintain flow :

PM voltage output list :

Signal name	Output reference value	Test point
VPROC_PMU	0.7~1.4V	L501
VPA	0.5~3.4V	L502
VSYS_PMU	2.2V	L503
VRF18_PMU	1.8V	C216

Main supply voltage see 5.1.2 picture , part of LCD see below picture mark :

For several other main power short circuit phenomenon, refer to 5.1.2 analytical process to determine whether these power shorted to ground, the processing method is to remove several inductors L501, L502, L503, and testing the two PAD inductive impedance to ground. If the PAD near PMIC shorted to ground, which means that the PMIC is bad, on the contrary, it means the back of a short circuit inductance.

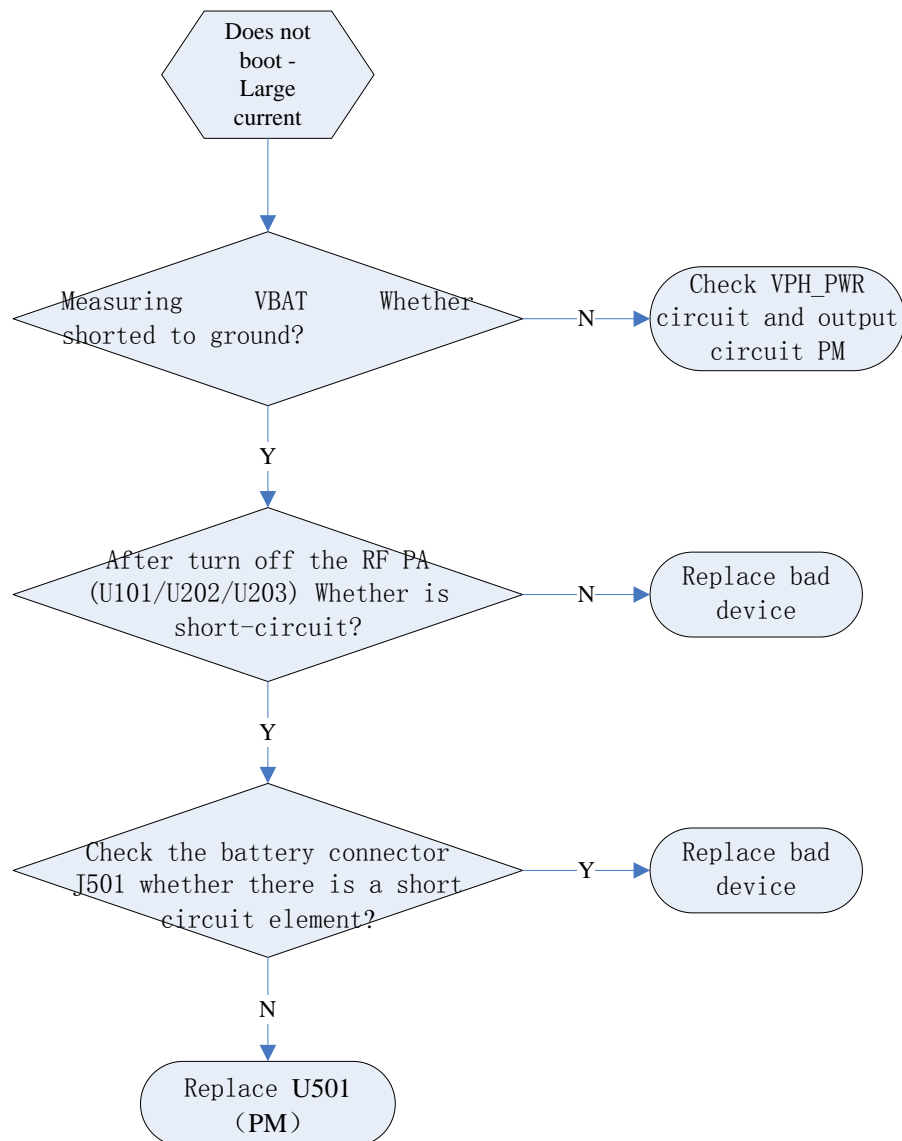
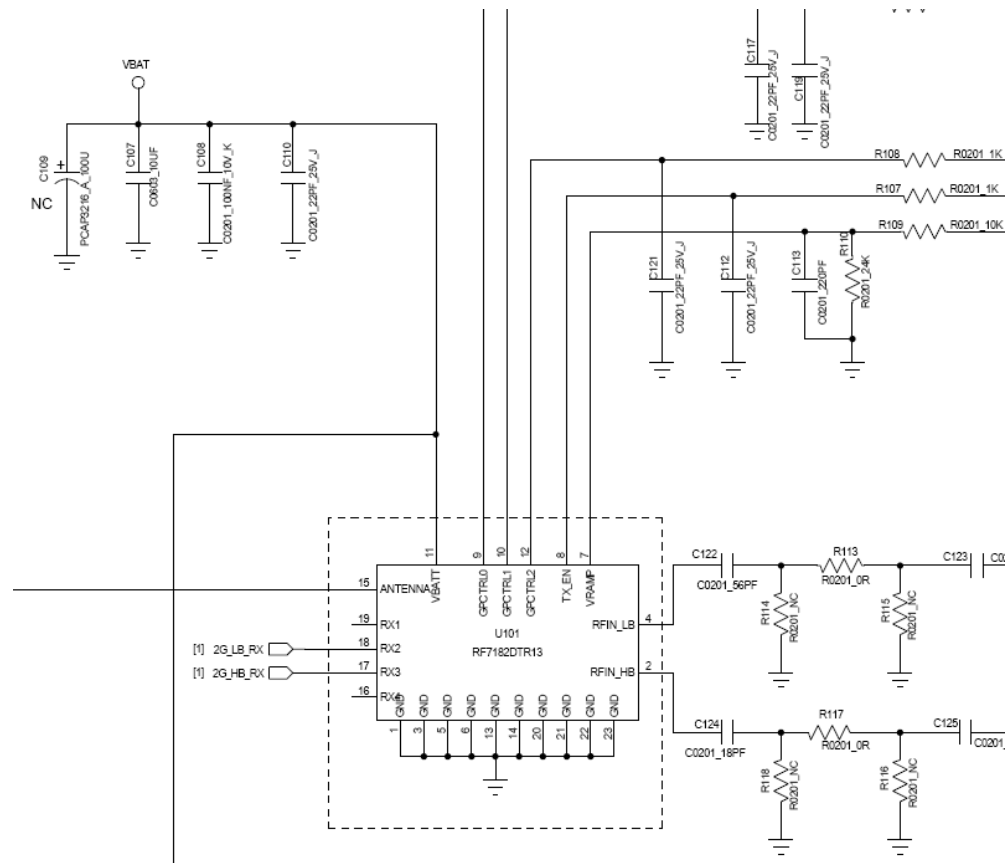
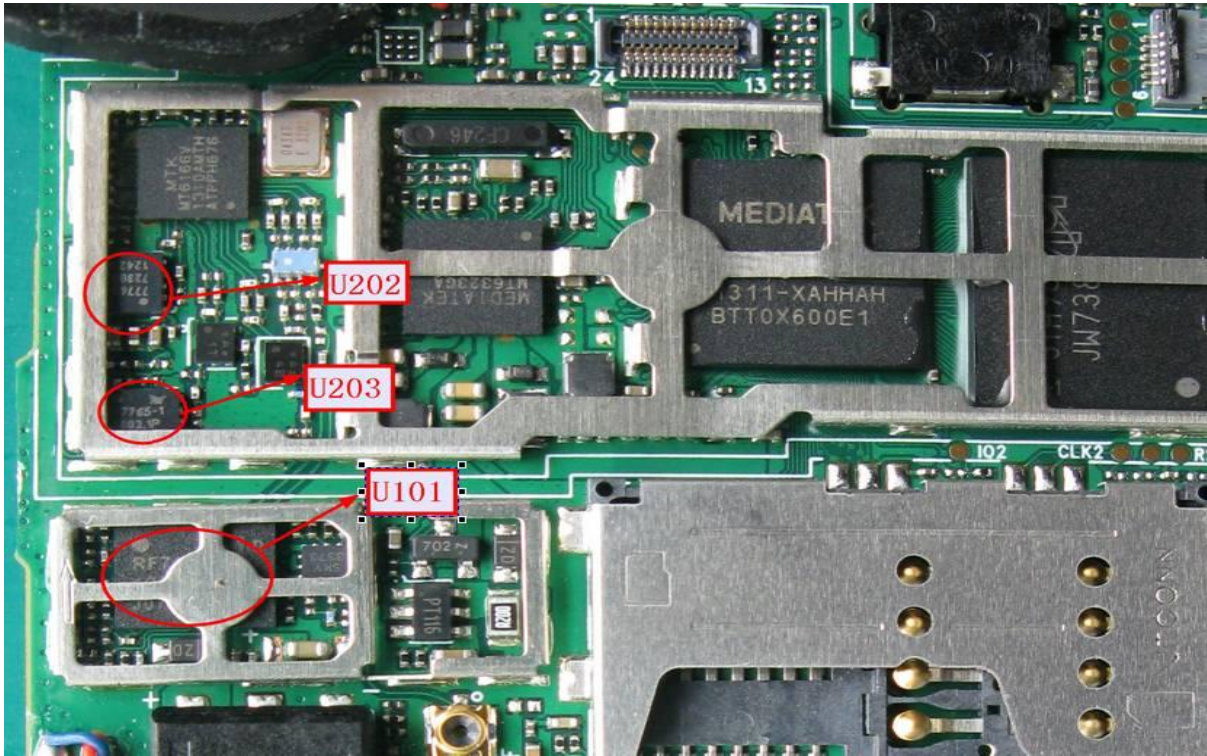
### 1. 4. 3 Large current (direct-current main power supply)

Large current ( current greater than 500MA ) divide 2 situation :

- 1 ) press power key appear large current ; This type of situation mainly is due to PM damage or PM output current short circuit cause.
- 2 ) too large current (off-state current is greater than 500MA). VBAT is mainly caused by short circuit to ground

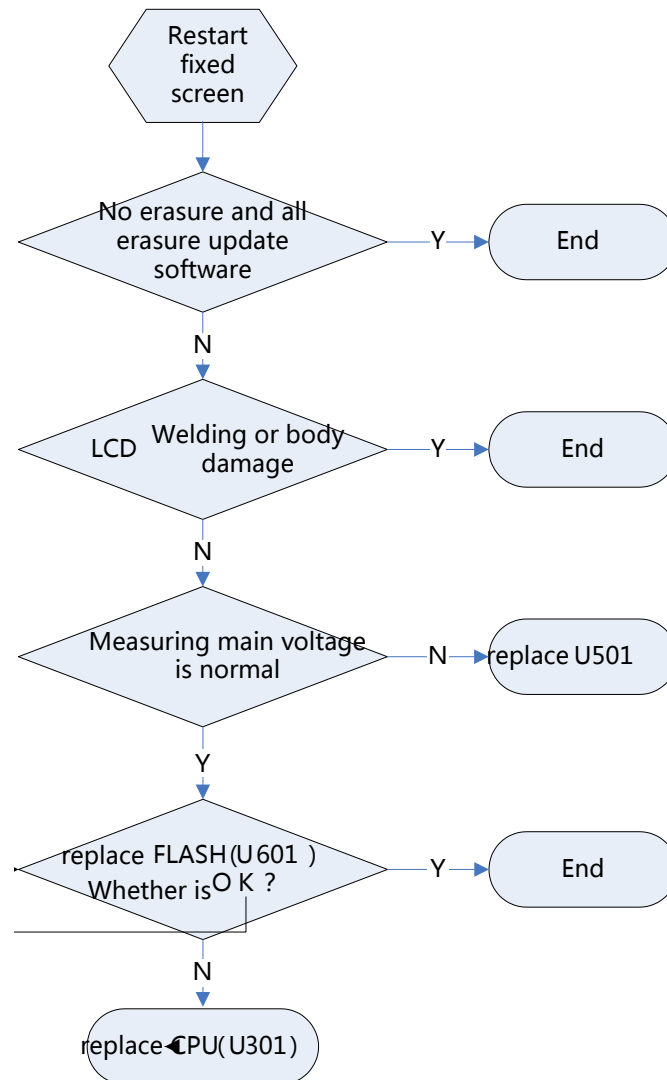
## 1.5 Restart fix screen

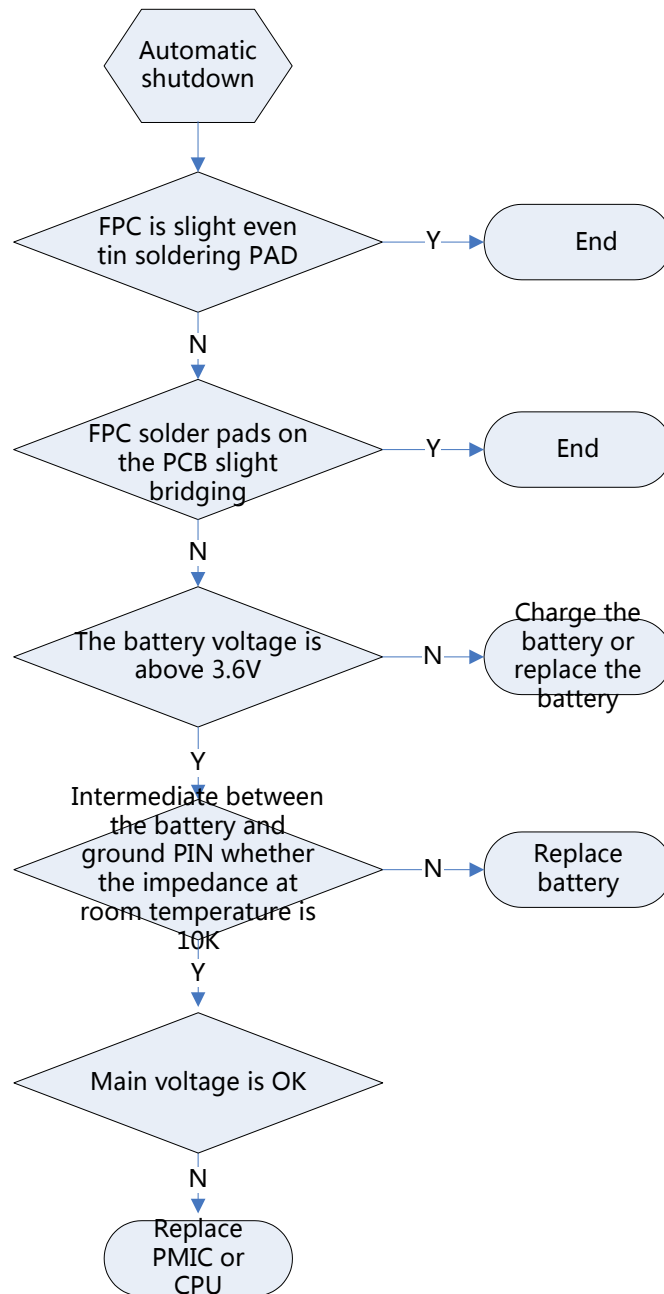
- 1) Start up , FPC' PAD welding is slight short circuit link tin
- 2) Start up, pad on the FPC welded PCB whether slight short circuit link tin
- 3) Judge cell voltage whether above than 3.6V
- 4) Judge PIN in the middle of battery and among earth impedance whether 10K in the normal temperature.
- 5) Above is OK , can check key power supply whether have short circuit phenomenon, thus can judge whether PMIC and BB chip etc and affiliated RC device cause.

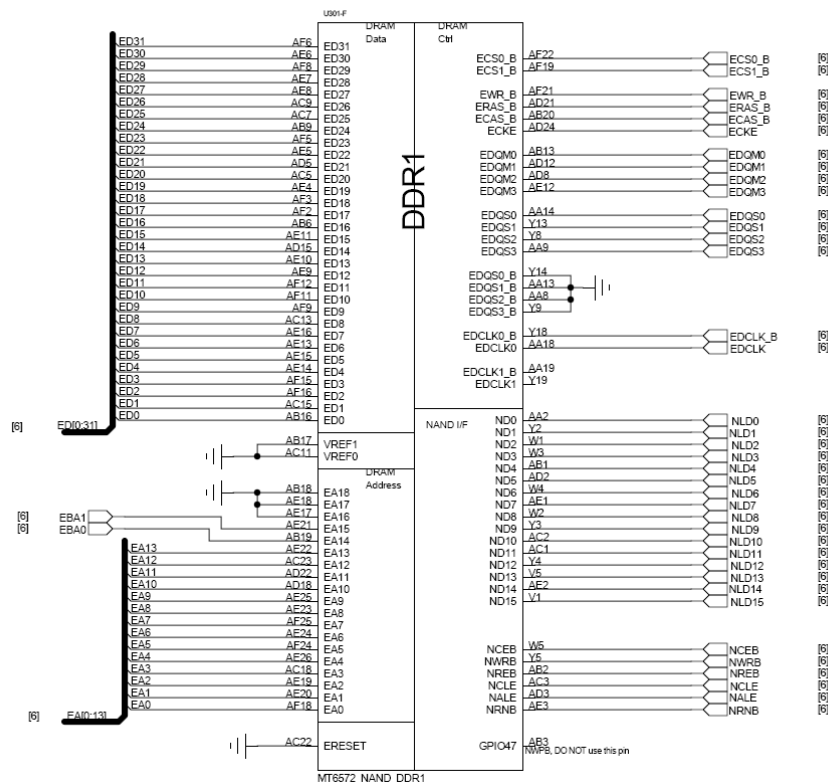
3) And then, consider CPU chip problem, CPU noumenon break down or weld cause FLASH corresponding data as well as order place mistake, it may be take place crash phenomenon.

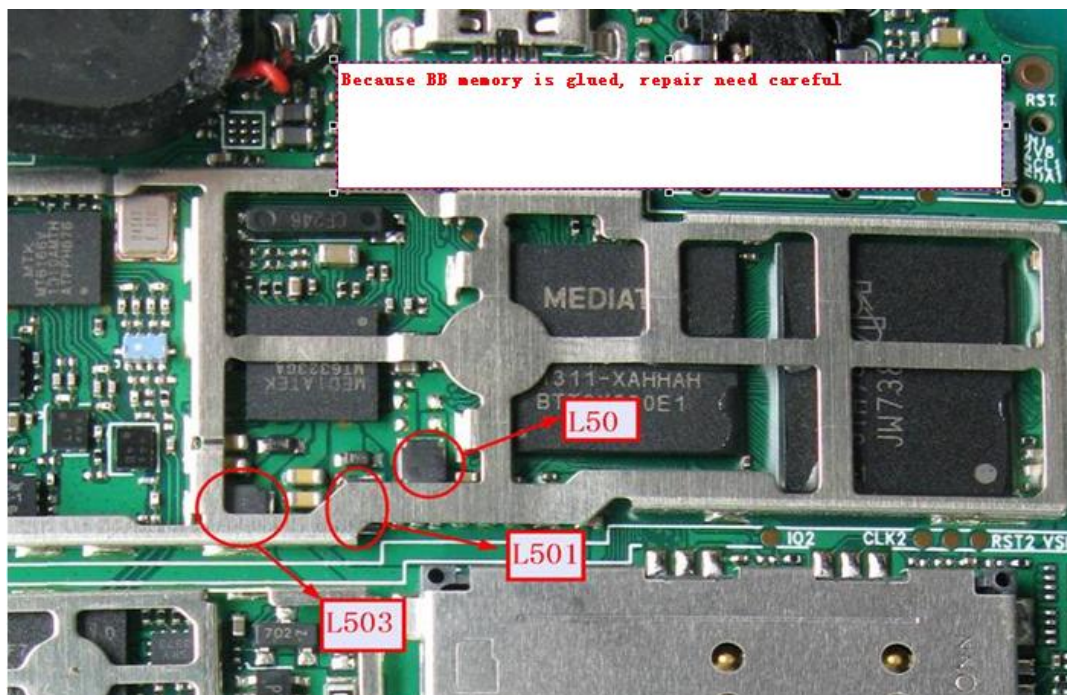
In brief, for L501 inductance, if close to PAD of PMIC over the ground short circuit, it can judge PMIC is bad, if another PAD short circuit, it can see link to CPU from internet, CPU is bad, this phenomenon is in the majority. ;

For L502 inductance, if close to PAD of PMIC over the ground short circuit, it can judge PMIC is bad, if another PCD short circuit, it can see U202 , U203 linked to internet is bad.

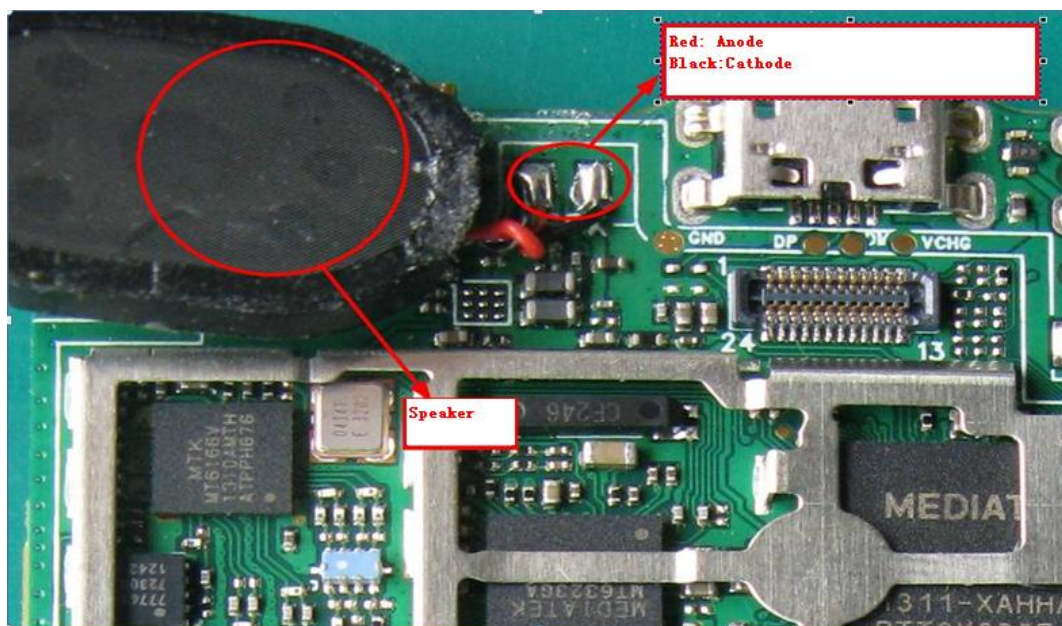
### 1.8.1 Speaker is bad.

Can change another speaker to check, speaker location :

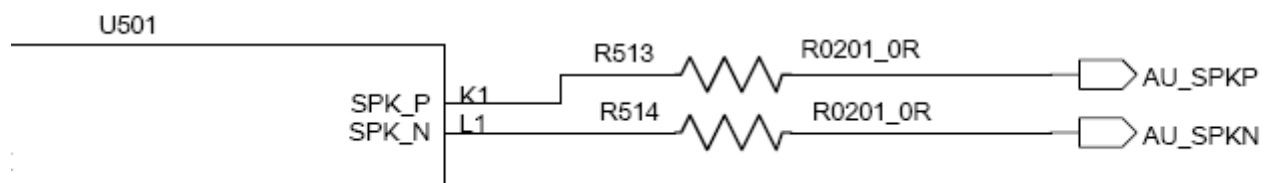
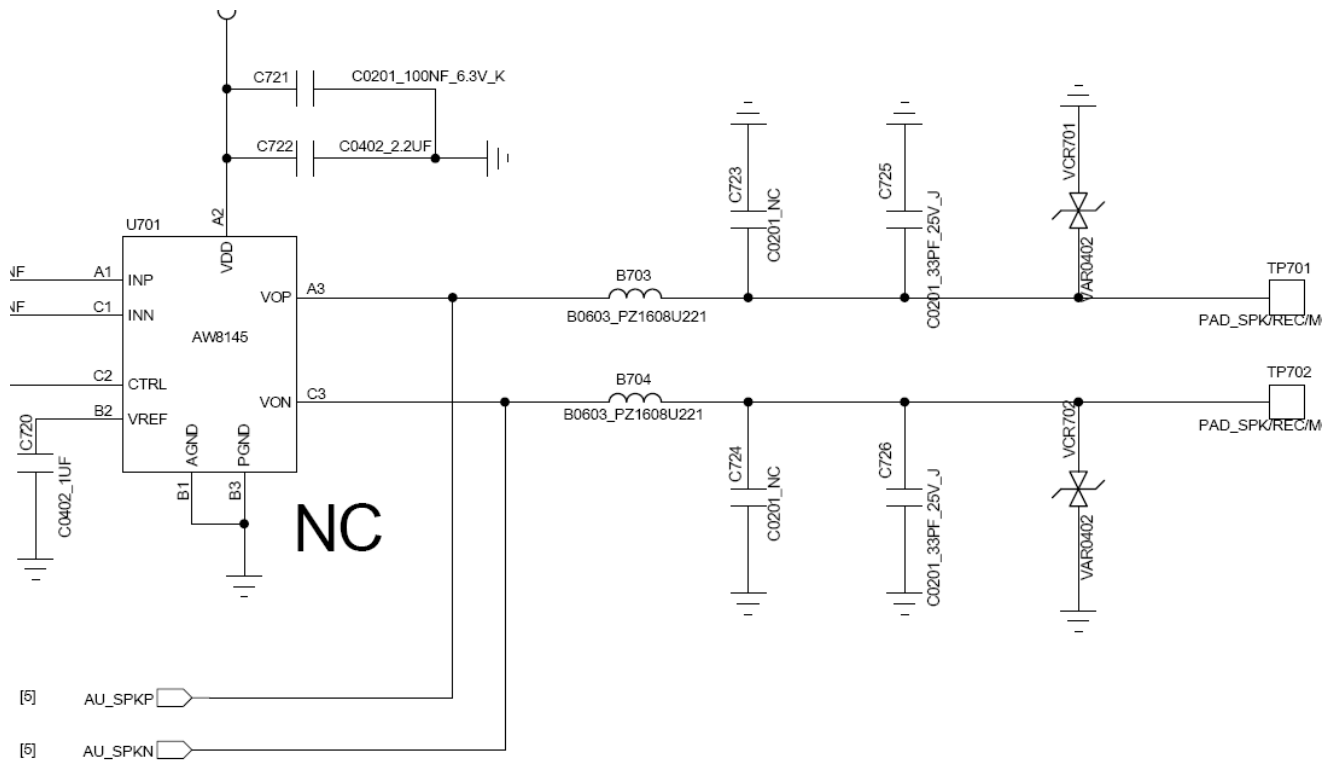
### 1.8.2 Speaker access

From above principle part, we can see speaker access from U501, R513,R541' s  
OR set out , and pass B703 , B704 to reach speaker, so need to make sure the  
resistance and magnetic bead whether is OK. :

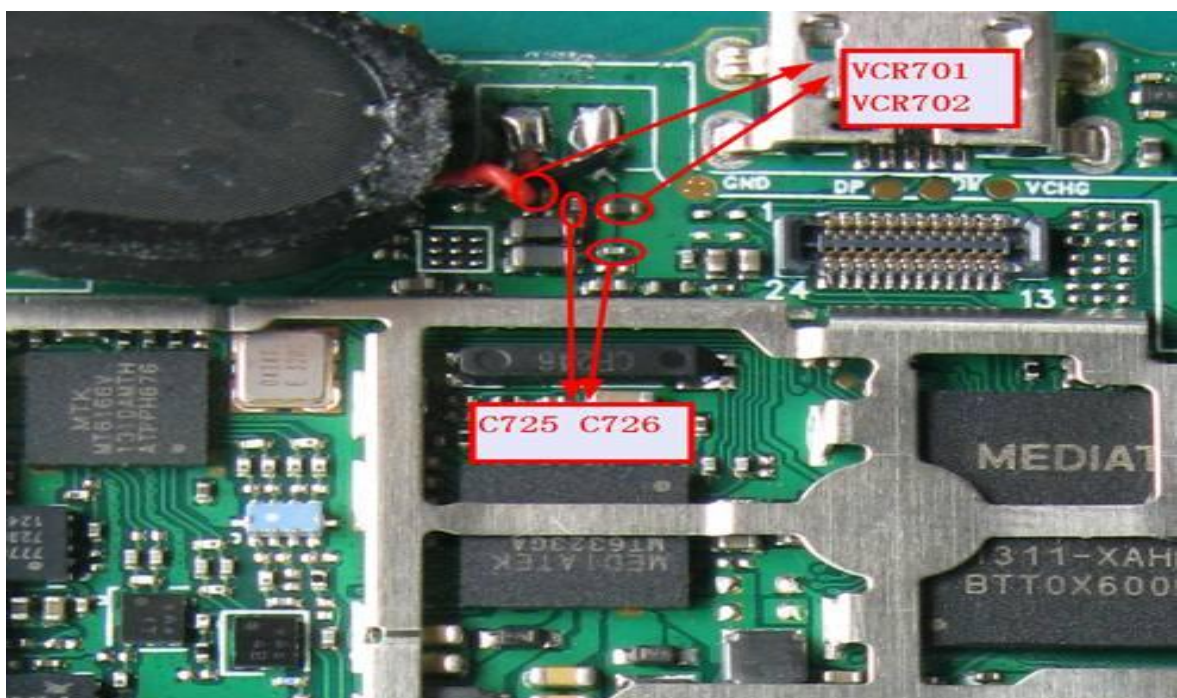
All of are OK, need to CHECK C725,C726 , VCR701 , VCR702 whether have over the ground short circuit phenomenon :

Last, above is OK, it can judge PMIC U501 chip bad.

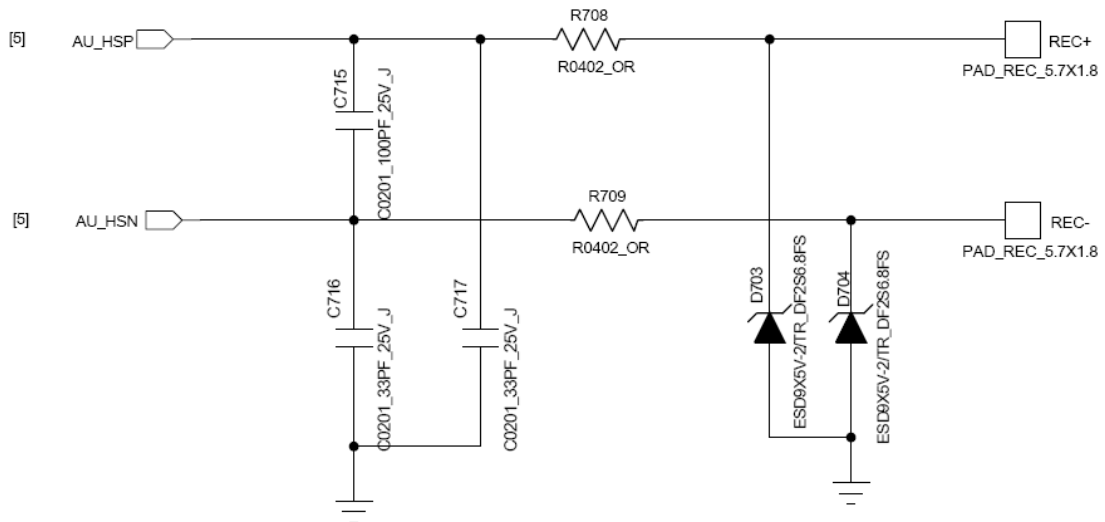
# Receiver

receiver circuit as shown in picture, REC +、REC - for baseband chip exporting receiver signal, output for RECEIVER.

Repair process: check whether the welding RECEIVER is good; checks around the earpiece device (R708, R709, C715, C716, C717, D703, D704) for damage or short circuit, Weld, as described above are silent under normal circumstances, the handset can be judged to baseband chip U301 welding problems.

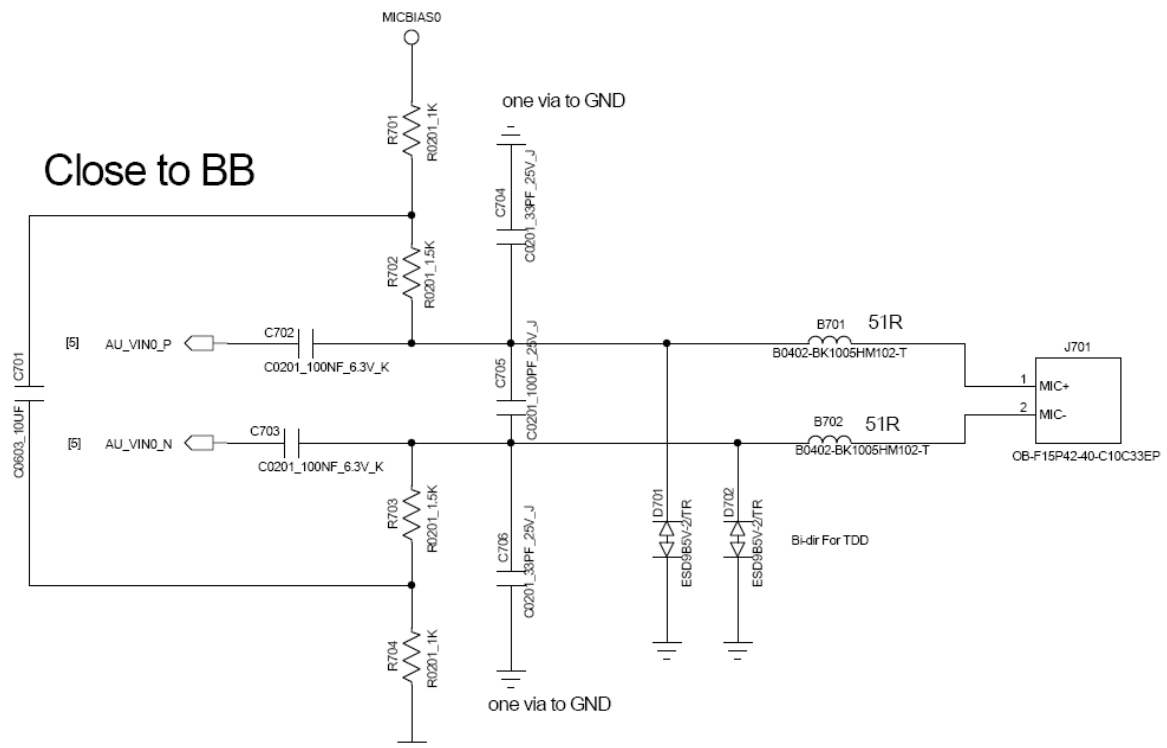
# Main MIC

Part of receiver circuit as show in picture, MIC audio input signal is differential signal, then the baseband chip MIC input channels, VMICBIAS0 work for the MIC bias voltage.

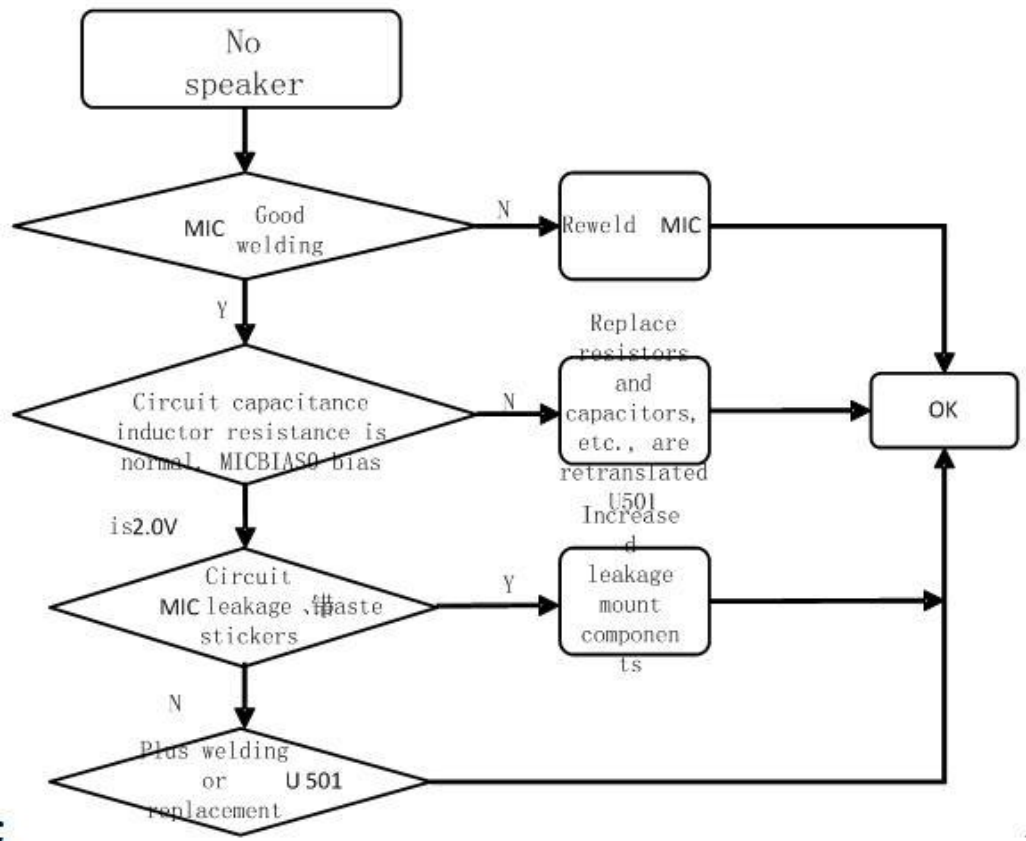
Overhaul flow : check MIC weld whether is OK, can change MIC test; put through telephone, measure mainboard MIC circuit magnetic bead capacitance weld whether is completed ;

MICBIAS0 whether have 2.0v bias; check MIC circuit whether have tainted stickers, stickers wrong question; additional welding baseband chip U301;

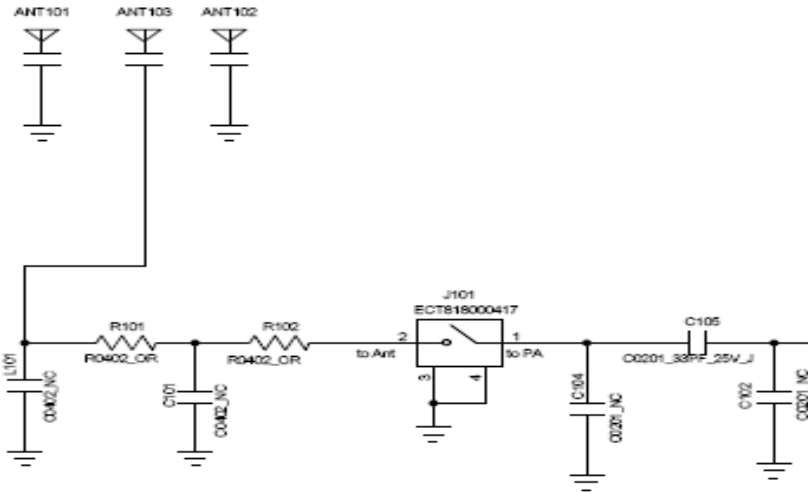
- 1) Firstly check whether the antenna shrapnel contact pins bending or breakage, change it if have.
- 2) And then, check R101、 R102 device whether have leak stick or dry joint phenomenon.

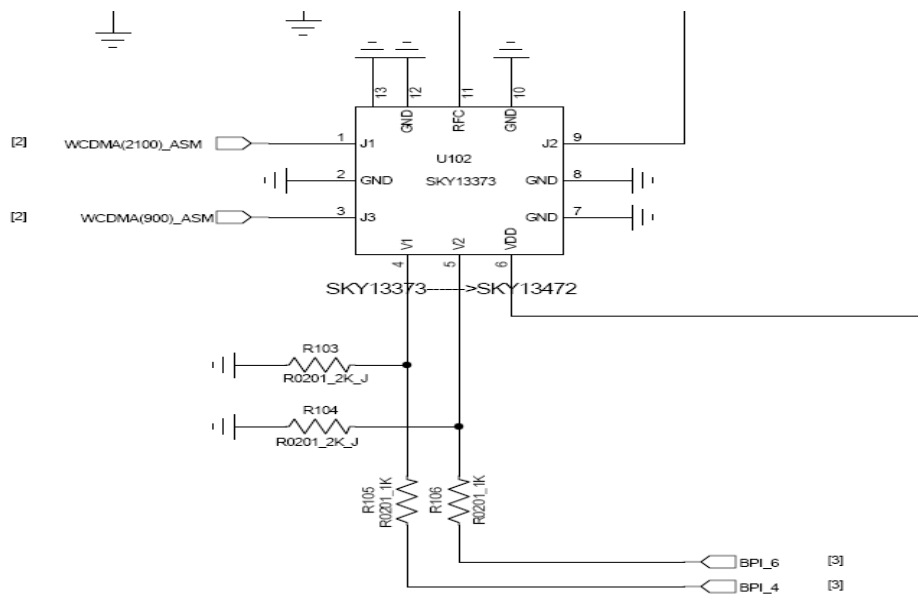
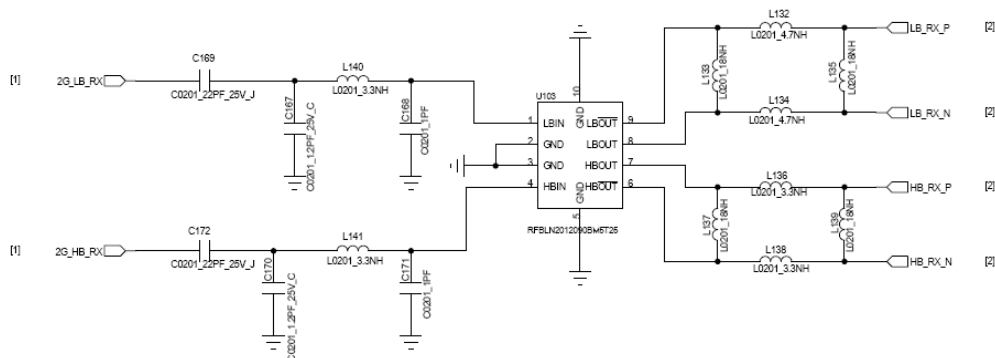
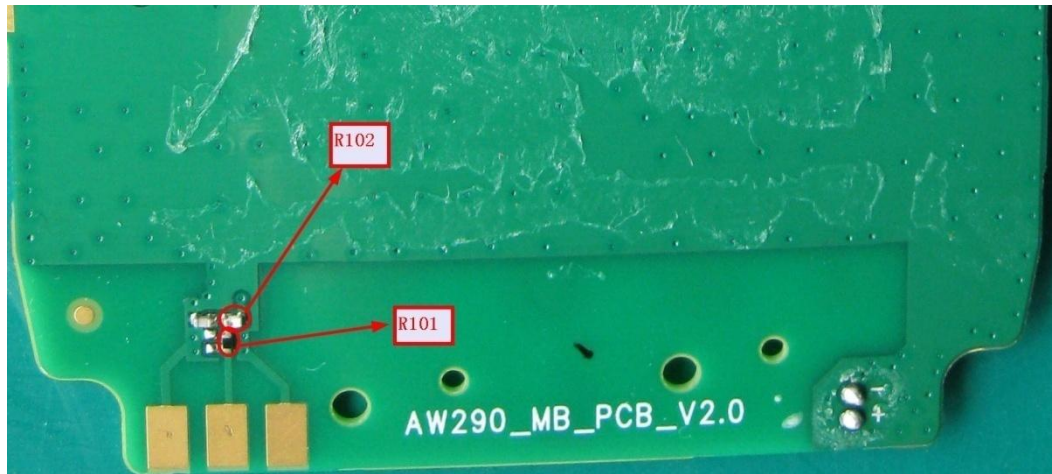
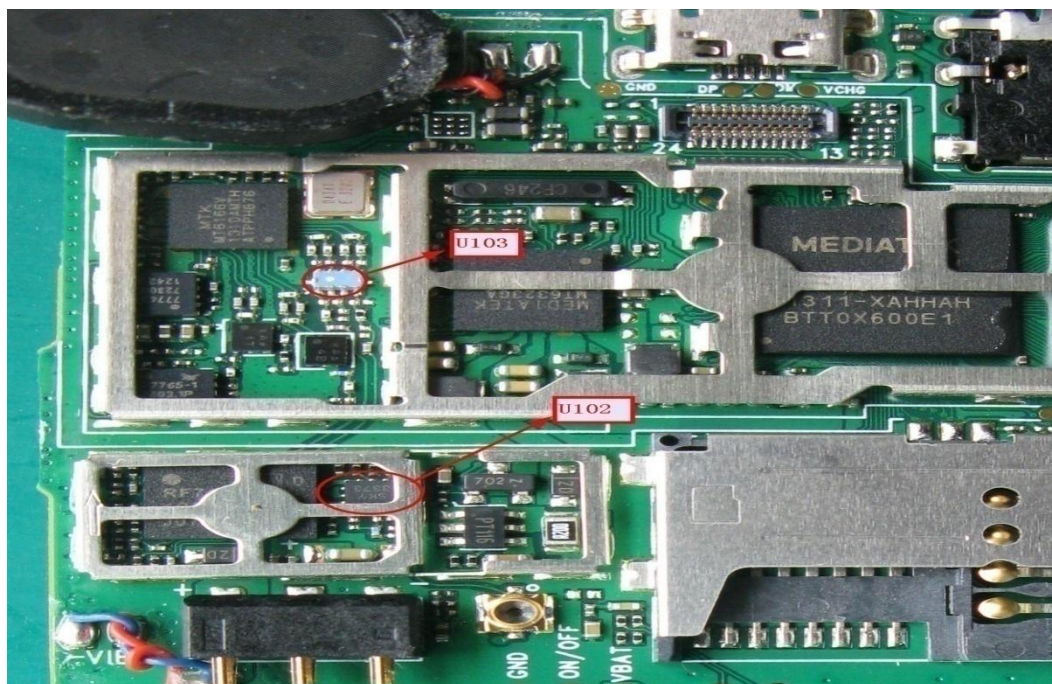
3) Check U102、U103 whether have dry joint.

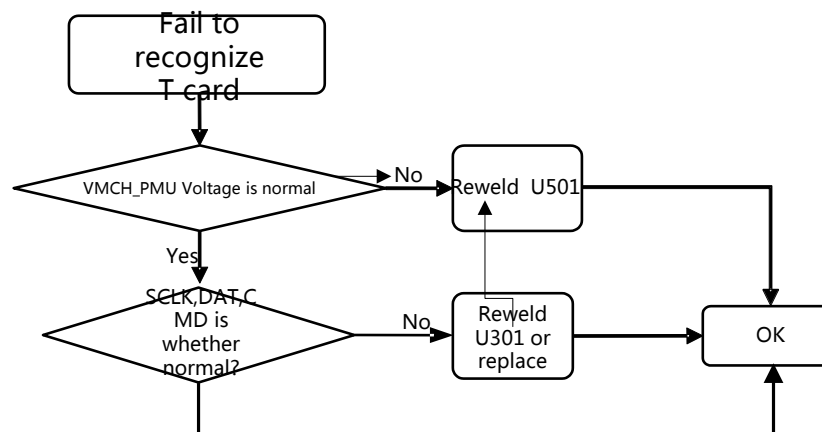
### 1. 12. 2 Fail to recognize T card.

T card in the signal path and no series resistance, analytical process is as follows :
