# YU220 advanced edition maintain service V1.0

Huawei Technologies Co Ltd

# CHAPTER 1 MAINBOARD OPERATING PRINCIPLE

## MOBILE PHONE FUNCTIONAL BLOCK DIAGRAM INTRODUCTION

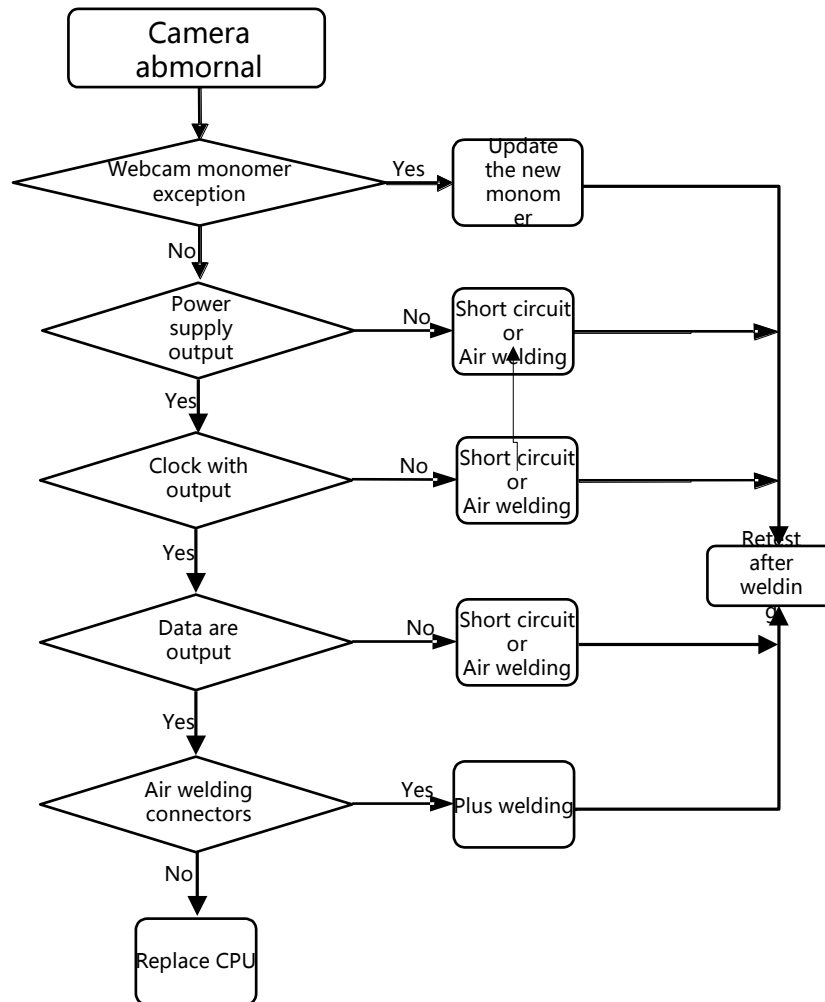
General phone camera without image, there are four possibilities: firstly get rid of LCD failures. 1. Camera bad; 2, camera and the socket bad contact; 3, connector dry joint. 4, CPU chip U301 exception. So first determine whether there is power cord, if the power cord abnormalities, first determine whether a short circuit, short circuit, please remove the appropriate path if the capacitance, if not short-circuit the plus welding PMU circuit; look at whether there is a clock signal output without output, you can first add welding CPU chip; see if there is signal signal line, if not, then the CPU exception, can be welded CPU retest. If the external signal has, then we can conclude that the connector is bad, can be welded in the test.

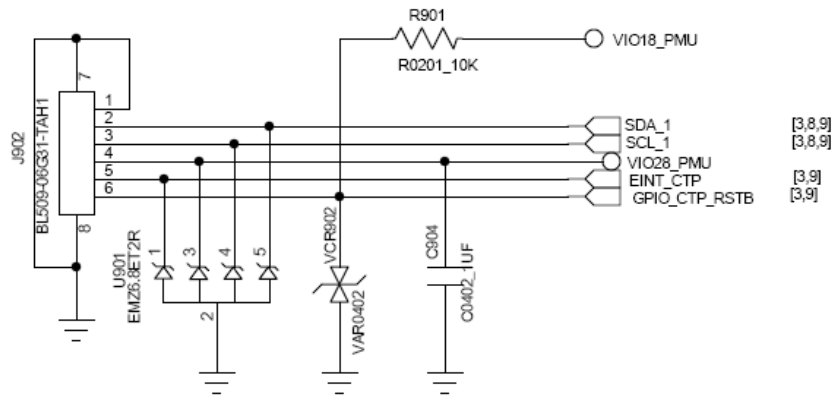
# CTP

CTP failure is generally unresponsive touch, unresponsive, touch point bounce, etc., please replace the new CTP, see if you can solve the problem, if it still cannot be solved, according to the following steps :

- 1、 Input power is normal, if the input voltage is abnormal, first determine whether a short circuit, remove the capacitors on the line after the short circuit. Measurement, there may be chips and connectors J902 U501 causing a short circuit can be re-welded and then measuring
- 2 、 Reset signal is pulled up, if the working time is low, the CPU exception, can be welded and then measuring.
- 3、 Is there a control signal output, use the oscilloscope to measure whether there SDA0 and SCL0 signal output, if abnormal, U301 body bad.

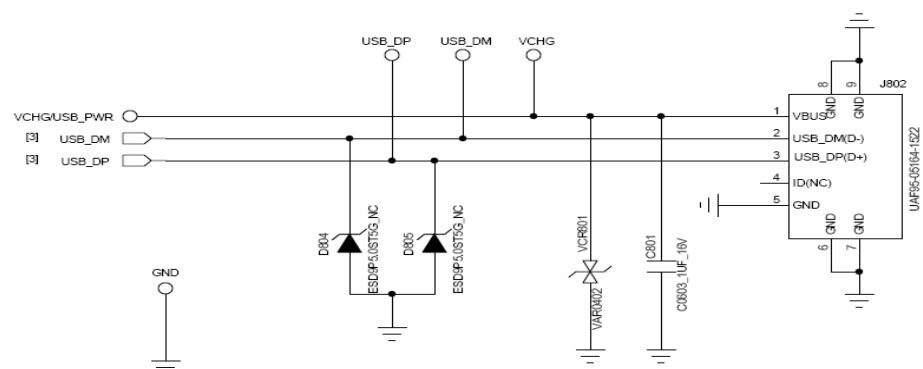
Failure Analysis: The phone cannot charge. The failure are usually two situations: First, connect the charger to the phone, the phone did not respond;

The other one is a mobile phone while charging display, but cannot charge the battery. For non-charging fault plane, first test I / O interface, see if there is visible damage

Maintain process :

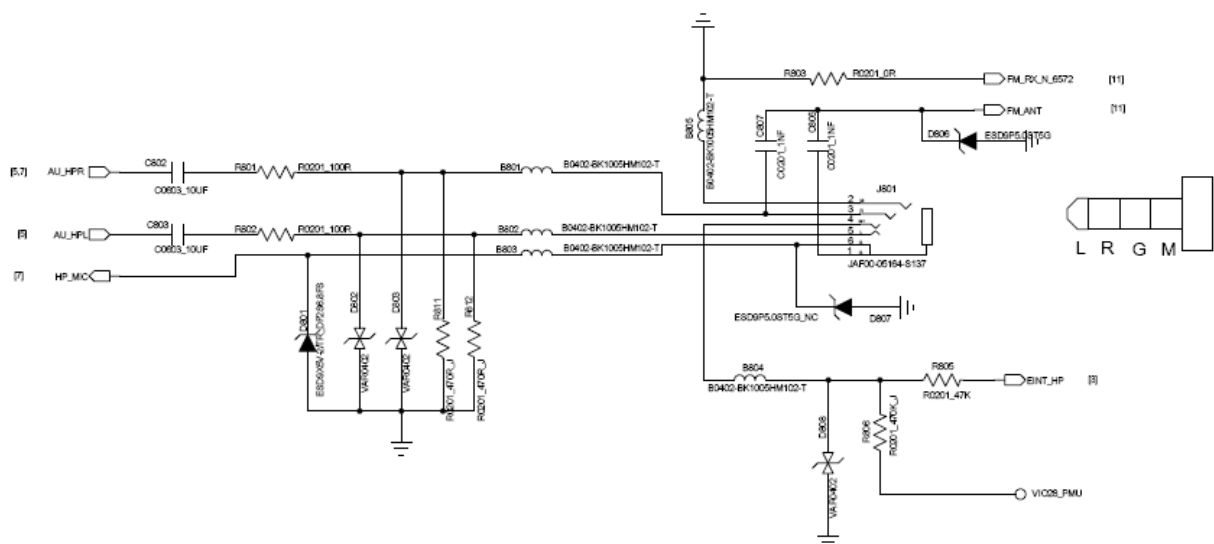
## Audio Jack

Earphone schematic diagram :

Fault 1: Insert the headset, silent, unable to detect headphones plugged;

Repair process: First, replace with a new headset first to see if the recovery exclusion headphone monomer problem, if not the headphones monomer confirm the problem, then the headset is plugged into, whether measured EINT\_HP signal is pulled low, not pulled low and then sequentially detects R805 whether Weld, B804 bead inductors are Weld, headphone socket is soldered, the headset is bad;

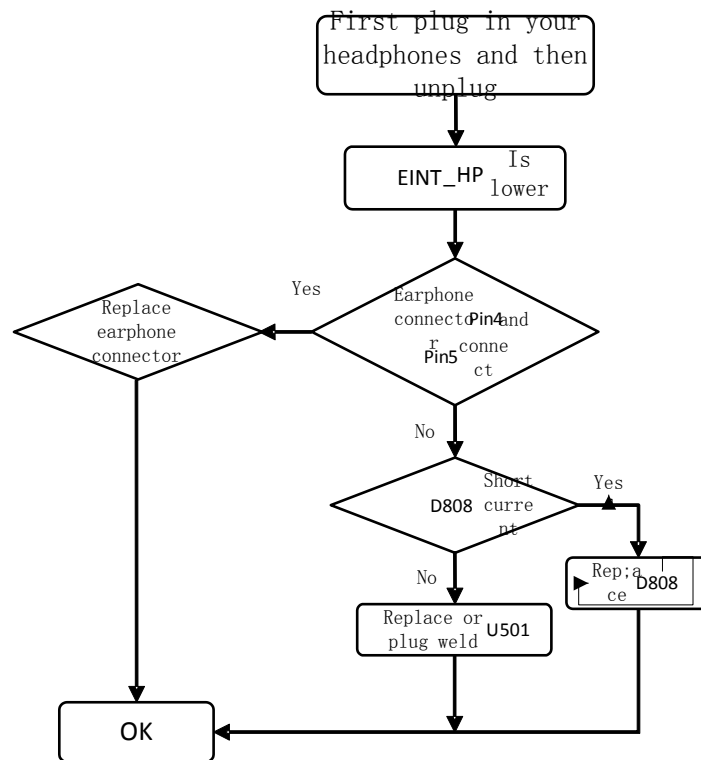
Repair process: first rule headset monomer problem, if not the headphones own fault, then plug in your headphones and then pull out after the first measurement EINT\_HP whether the signal has been low, if the test has been low, respectively, B801, B802, short circuit (may be sequentially removed B801, B802 look headset unplugged, EINT\_HP signal is set high)

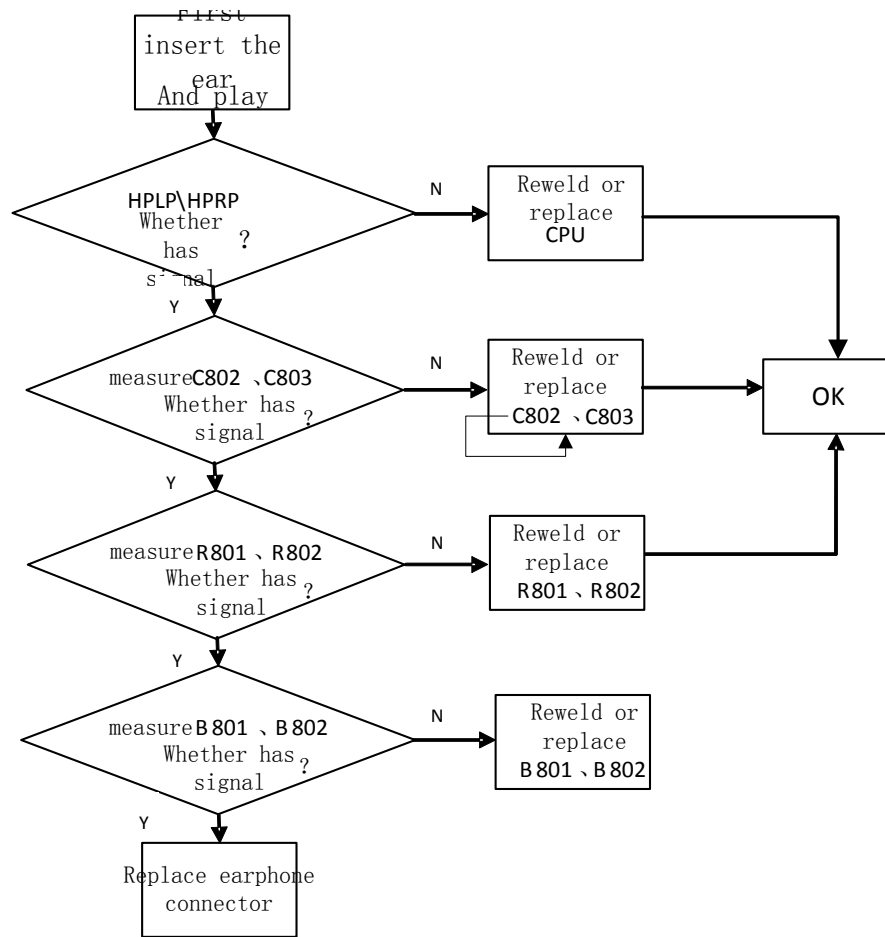
Repair process: first rule headset monomer problem, then plug in your headphones and play the ring tone and other audio signals with an oscilloscope measurement HPLP \ HPRP out from the baseband chip signal, and then followed by measurement of C802, C803, R801, R802 side, then B801, B802-side, then turn the investigation where the problem.

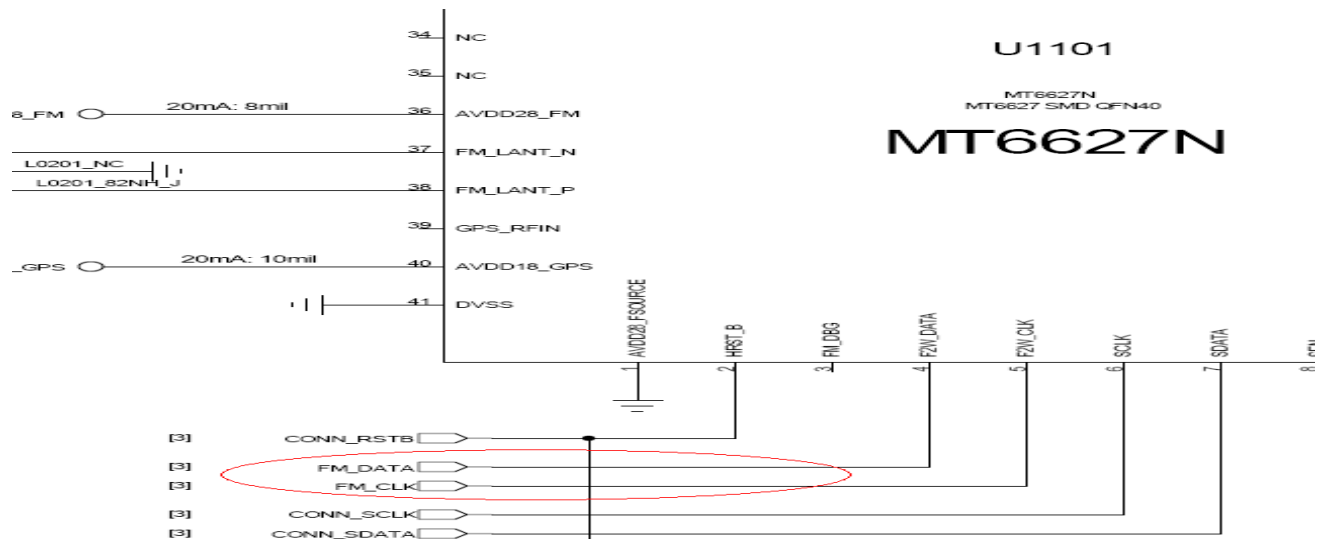
Schematic diagram:

External supply its 26M working clock CONN\_XO\_IN, FM chip is powered by the PMIC LDO 2.8V power output AVDD28\_FM. Headset as the FM antenna, FM demodulation chip receives the output audio signal (FM\_DATA, FM\_CLK), two channel audio signal is connected to baseband chip, the baseband chip to do the switching process.

Repair process: FM function in the open state, see the headphone port antenna PIN correctly. Measuring AVDD28\_FM voltage is normal, if not normal instructions powered PMIC Weld or damage, such as normal and then measuring FM\_DATA, FM\_CLK signal is correct, if not correct the problem is U301; signal if the above is correct then to see whether the FM chip U1101 Weld or damaged.

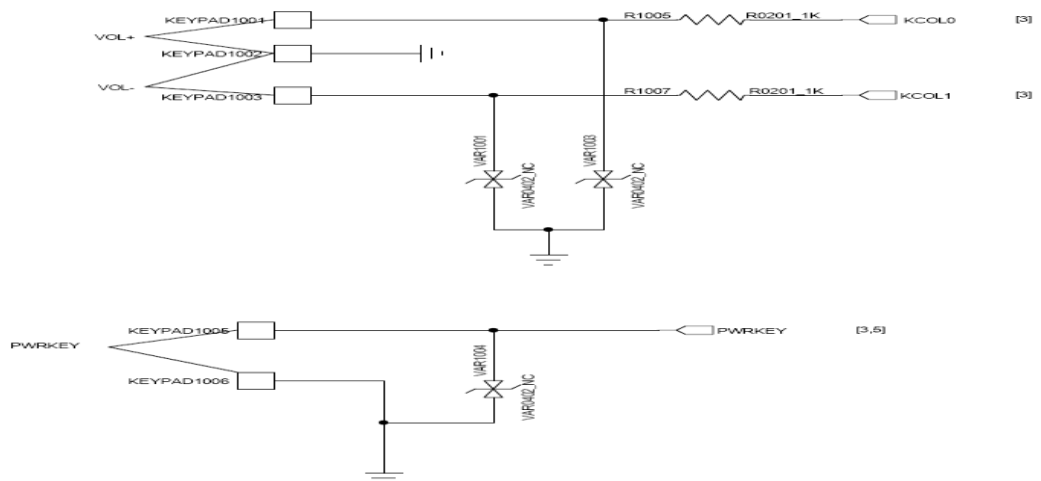
Side key circuit :

Side key include volume key and power key.

Up and down keys to communicate with the U301, the first rule out side-FPC monomer and welding no problem, consider two resistors R1006, R1007 are OK, and then determine when pressing the upper or lower button when the upper or lower key is shorted to ground, if it means short-circuit the normal, not short-circuit the problem can be determined U301 chip, the chip can be changed. Power button is on the U501 communication, first rule out FPC and welding monomer no problem, consider whether short varsities, and then consider the U501 problem can be.

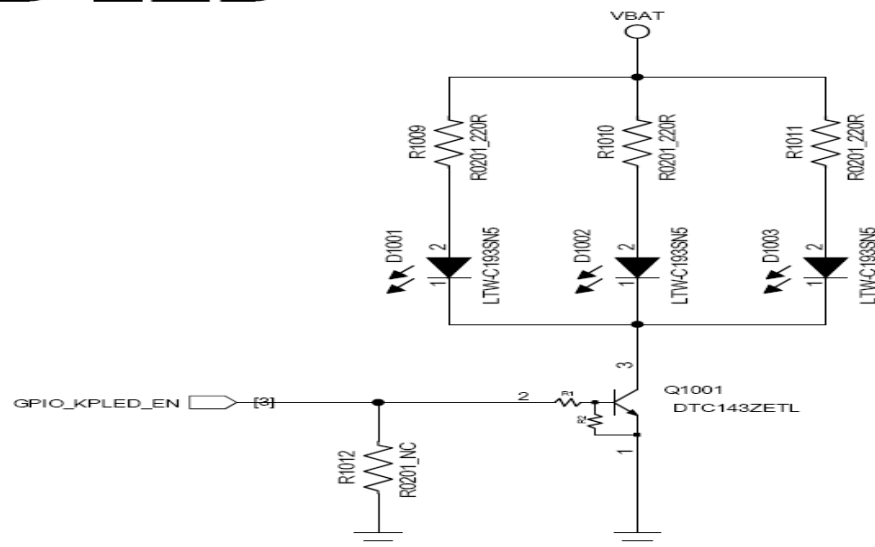
# 'PAD LED

U301 keyboard lighting is by issuing an enable signal GPIO\_KPLED\_EN makes transistor Q1001 is turned on, then the three keyboard lights.

Firstly judge the keyboard light paster whether have problem, dry joint or short circuit, or reverse weld problem, it need to affirm welding series resistor whether unusual if the light have no problem.

Finally, whether the transistor is installed is damaged, or does not turn-on voltage.

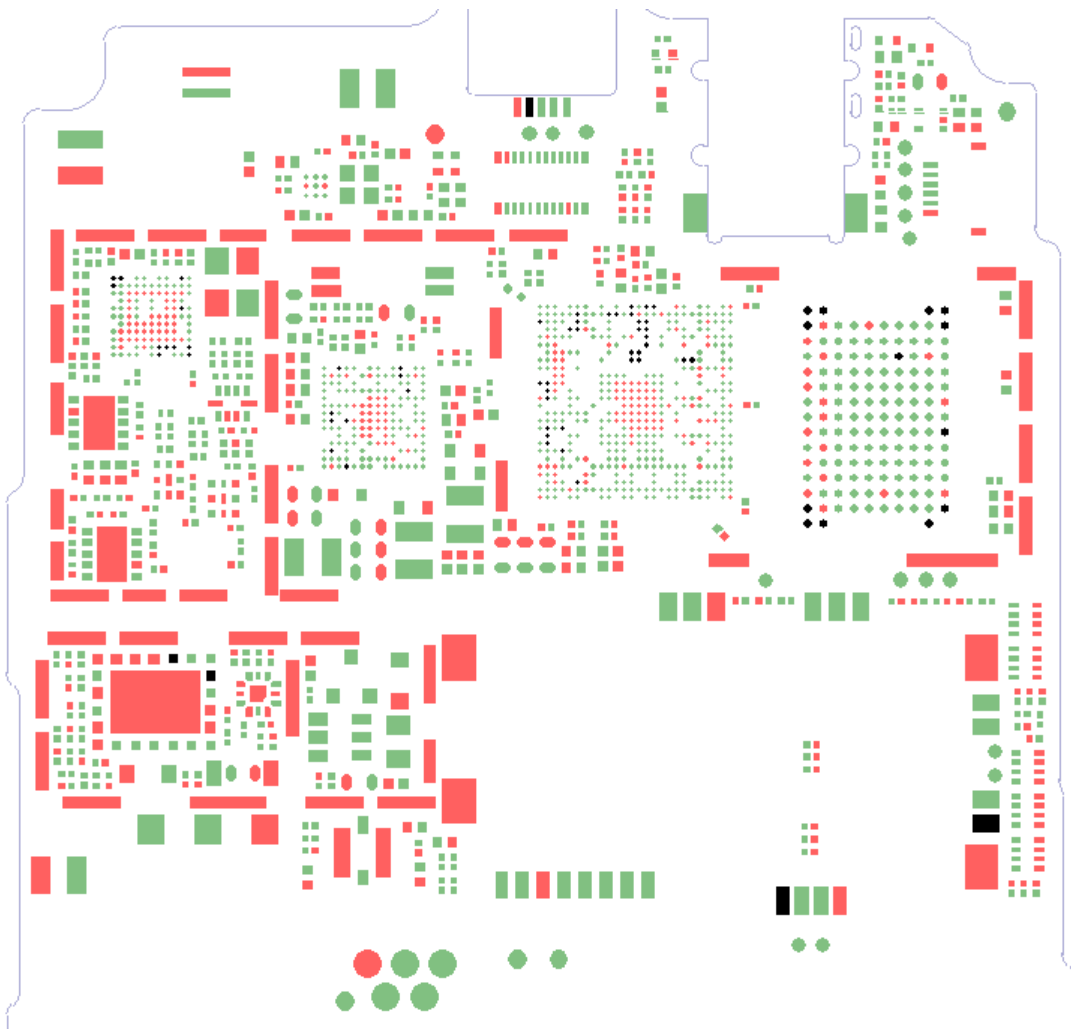
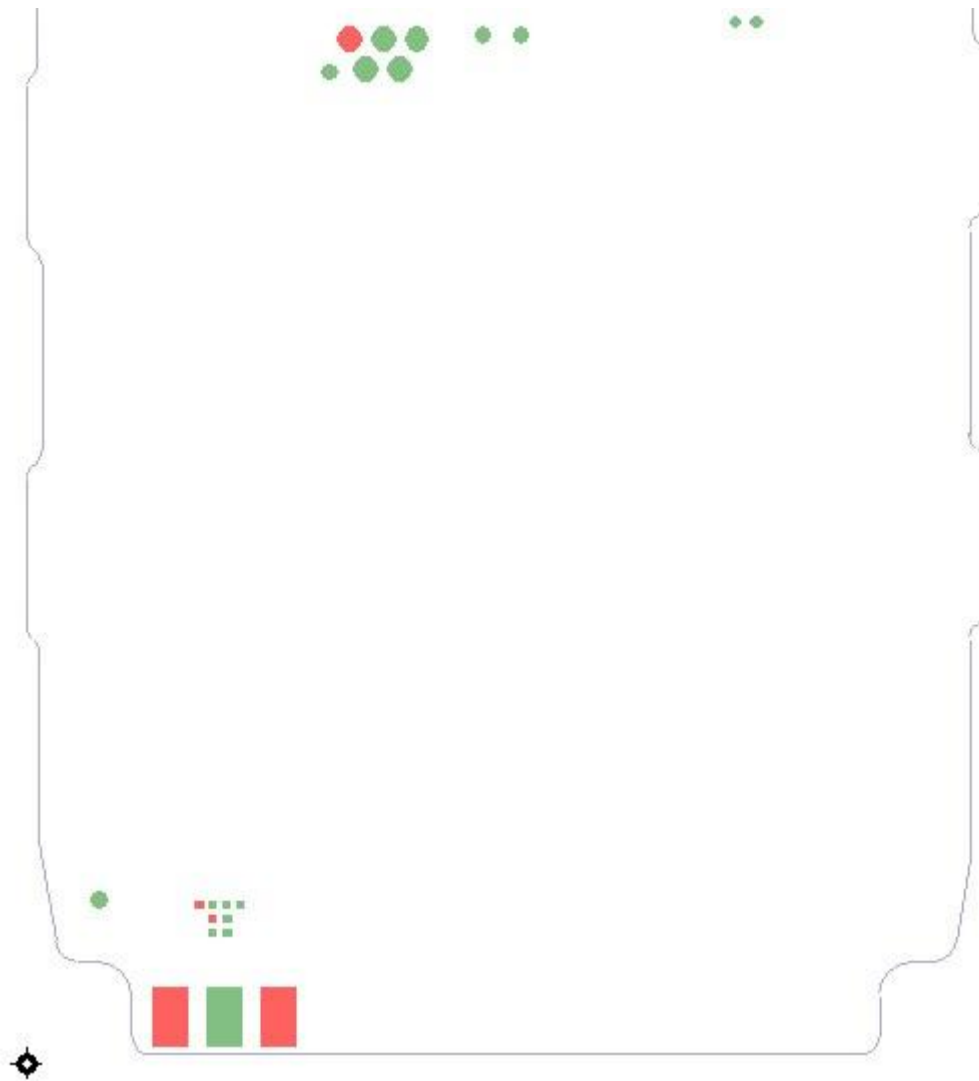
Front :

Mainboard graph:
